# Drinking Water Audit Report

<b>County:</b>	Wexford	<b>Date of Audit:</b>	7 <sup>th</sup> July 2017
<b>Plant(s) visited:</b>	Camolin Water Treatment Plant (3300PUB1779)	<b>Date of issue of Audit Report:</b>	11 <sup>th</sup> July 2017
		<b>File Reference:</b>	DW2017/91
		<b>Auditors:</b>	Mr. Darragh Page
<b>Audit Criteria:</b>	<ul style="list-style-type: none"> <li>• The <i>European Union (Drinking Water) Regulations 2014 (S.I. 122 of 2014)</i>.</li> <li>• The <i>EPA Handbook on the Implementation of the Regulations for Water Services Authorities for Public Water Supplies (ISBN: 978-1-84095-349-7)</i></li> <li>• The recommendations specified in the <i>EPA Drinking Water Report</i>.</li> <li>• EPA Drinking Water Advice Notes No.s 1 to 15.</li> <li>• The recommendations in any previous audit reports.</li> </ul>

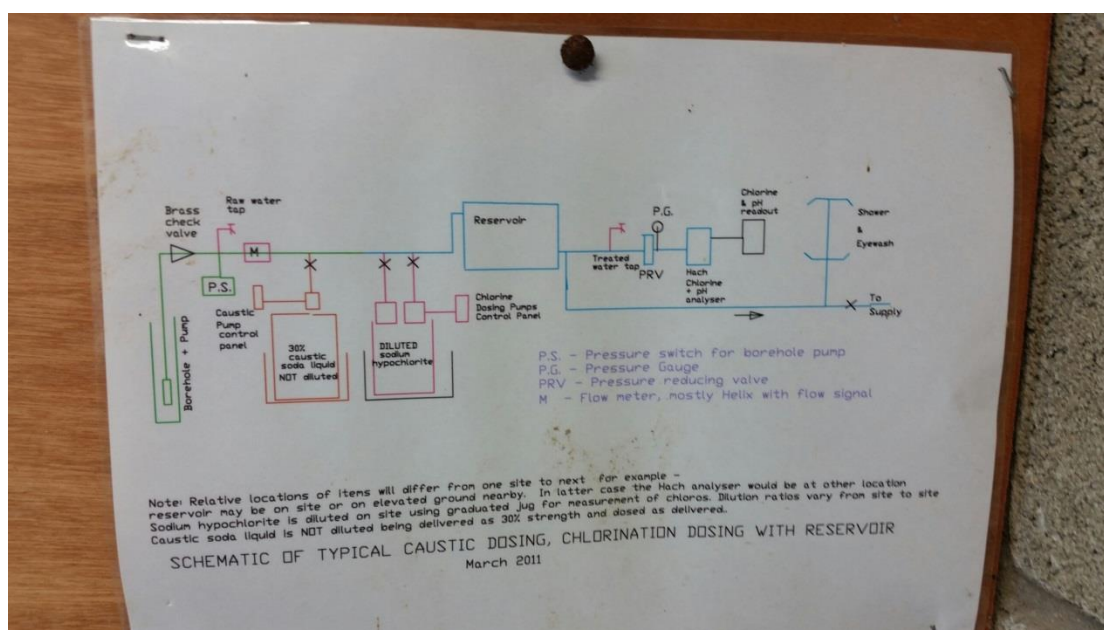
4.	<p><b>Management and Control</b></p> <ol style="list-style-type: none"> <li>The caretaker normally responsible for the management of the plant was on leave at the time of the audit and the plant was being managed by the relief caretaker.</li> <li>Neither Wexford County Council nor Irish Water staff were aware of the location of chemical dosing points at the plant and were unable to say, without sampling, which of the sodium hypochlorite and sodium hydroxide dosing points were in operation. Upon arrival at the site, the auditor was informed that the reservoir was a raw water reservoir even though it emerged that it was a treated water reservoir.</li> <li>The schematic at the plant was wrong and not representative of the how the plant operates. This could have had significant implications in the event of an incident when the plant is being operated and managed by relief caretaking staff.</li> </ol>

Photo 1. Schematic of the Camolin Water Treatment Plant.

- Irish Water should review the schematic of Camolin water treatment plant and ensure that it represents the correct sequence of treatment processes at the plant.

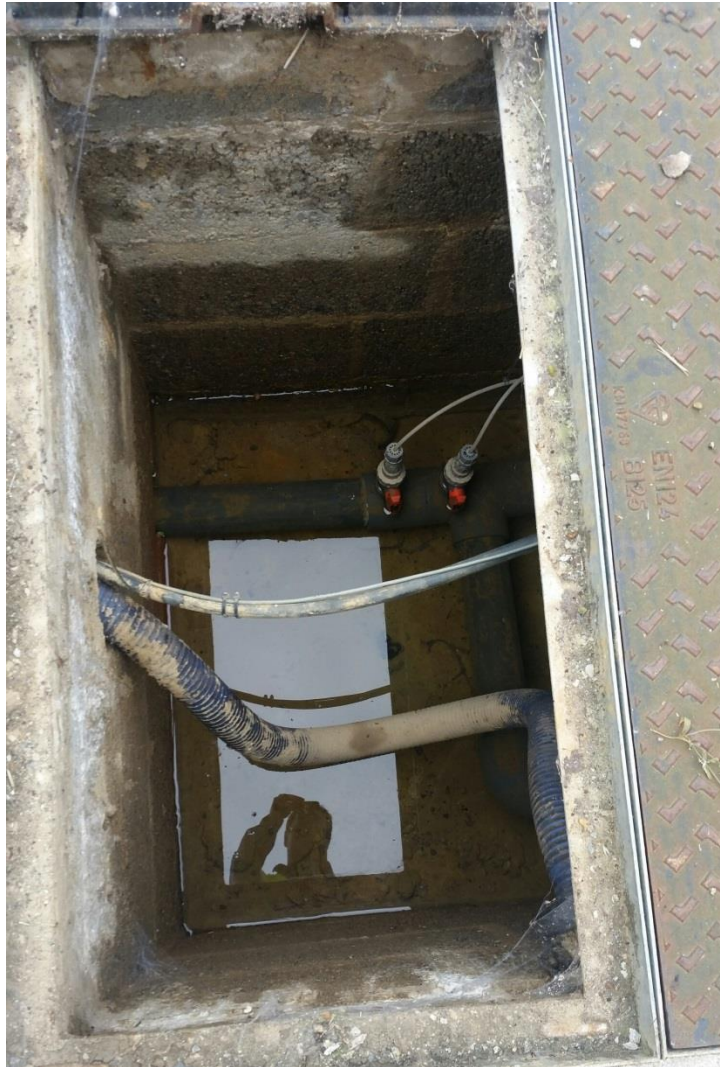
2.	<p><b>Disinfection</b></p> <ul style="list-style-type: none"> <li>a. The raw water is pumped from the borehole to a storage reservoir and is chlorinated using sodium hypochlorite.</li> <li>b. The manholes entering and exiting the reservoir were lifted and there were three chemical dosing lines on both the inlet and outlet. The valves on all dosing lines (with the exception of the first dosing line on the inlet) were in the open position. Initially, neither Irish Water nor Wexford County Council were able to explain which dosing lines were sodium hypochlorite and which were sodium hydroxide (i.e. whether they were dosed on the inlet or outlet). The schematic for the plant (see Photo 1) indicated that the inlet dosing points were in use, however, the closed valve on the sodium hydroxide dosing point on the inlet indicated that this was not the case. A sample of water from the reservoir was analysed and chlorine was found to be present which confirmed that the inlet was disinfected. This was contrary to what Wexford County Council staff had thought (the caretaker for the plant was on leave and the plant was being run by the relief caretaker). It was therefore assumed that the chlorine dosing points on the outlet are redundant but have not been decommissioned.</li> <li>c. The chlorine levels on the chlorine monitor on the outlet appear to be stable with the exception of a period of 3 hours on 6<sup>th</sup> July where Wexford County Council stated that the power failed resulting in a loss of signal from the chlorine monitor. Water continued to be supplied to the village from the reservoir but no water was being pumped from the borehole to the reservoir and therefore it is likely that chlorine levels in the water supplied to consumers were adequate.</li> <li>d. The outlet chamber was partially filled with water (see Photo 2).</li> <li>e. There is a chlorine monitor and alarm and there was evidence that the alarm was functional in response to low chlorine levels.</li> </ul>

**Photo 2. Redundant Sodium Hypochlorite Dosing Points on the Outlet of the Reservoir (note the chamber is partially filled with water)**

- Irish Water should review the necessity for the sodium hypochlorite dosing points on the outlet of the reservoir, and if they are no longer required they should be decommissioned.

4. Irish Water should empty the standing water in the outlet chamber where the redundant sodium hypochlorite dosing points are located, and determine if the water accumulation there is due to a leak. Any repairs should be completed as soon as possible after the need has been identified.
