Drinking Water Audit Report

County:	Galway	Date of Audit:	4 th April 2017
Plant visited:	Portumna Public Water Supply	Date of issue of Audit Report:	12 th April 2017
	(1200F 0 D 1042)	File Reference:	DW2008/146
		Auditor:	Aoife Loughnane
Audit Criteria:	 The European Union (Drinking Water) Regulations 2014 (S.I. 122 of 2014). The EPA Handbook on the Implementation of the Regulations for Water Services Authorities for Public Water Supplies (ISBN: 978-1-84095-349-7) 		
	• The recommendations specified in the EPA Drinking Water Report.		
	• EPA Drinking Water Advice Notes No.s 1 to 15.		
	• The recommendations in any previous audit reports.

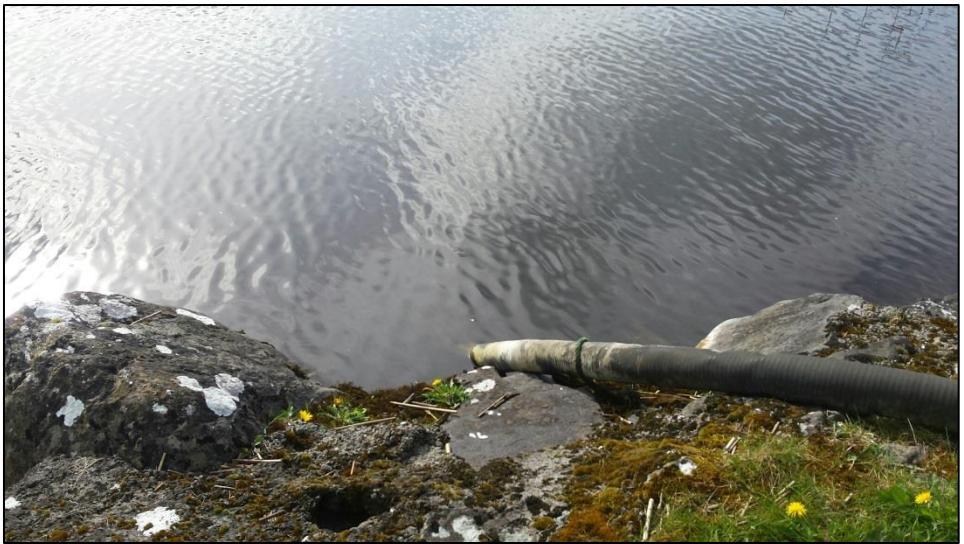
1.	Source Protection				
	a.	The raw water abstraction point in Lough Derg is located approx. 220m at a depth of $1.5 - 2$ metres. The intake pipe has been damaged by passing boats on a number of occasions. Irish Water stated that a diving company surveyed the damaged pipe 3 weeks ago and found that a 2 metre section of the pipe is missing approx. 70 metres offshore. Pipeline repair works are due to be completed this week.

D.	A temporary raw water intake point is currently in operation, abstracting water from the immediate shoreline (see photo 1).			
	с.	A hydrocarbon monitor and alarm has been installed on the raw water to manage the risk of hydrocarbon contamination from the adjacent marina.

Photo 1: Temporary raw water abstraction point on Lough Derg shoreline

1. Irish Water should ensure that the raw water intake pipe is repaired and safeguarded from any future damage by passing boats.

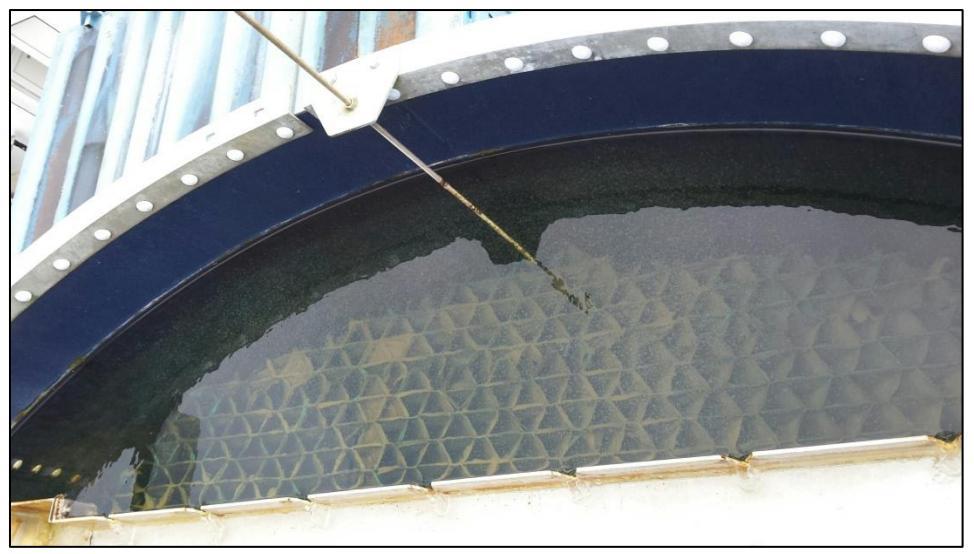
d.	On the day of the audit, there was a problem with the clarification process as both clarifiers had substantial amounts of floc rising to the surface, through the tube settlers, and carrying over onto the filters (see photo 2).

e.	Sludge is drawn off the sludge blanket in each clarifier for 1 minute every 7.5 minutes, from a single sludge bleed point.			
	f.	GCC confirmed that the clarifiers are cleaned every 3 months and are due to be cleaned again shortly.

Photo 2: Clarifier No. 2 showing floc rising to the surface & carrying over onto the filter

- 3. Irish Water should carry out an investigation to identify the cause of floc carryover from the clarifiers into the filters, to include an assessment of the sludge bleed regime and whether the clarifiers are being operated above their design capacity.

5. Irish Water should ensure that the clarifiers are cleaned on a regular basis to prevent the excessive build-up of sludge.

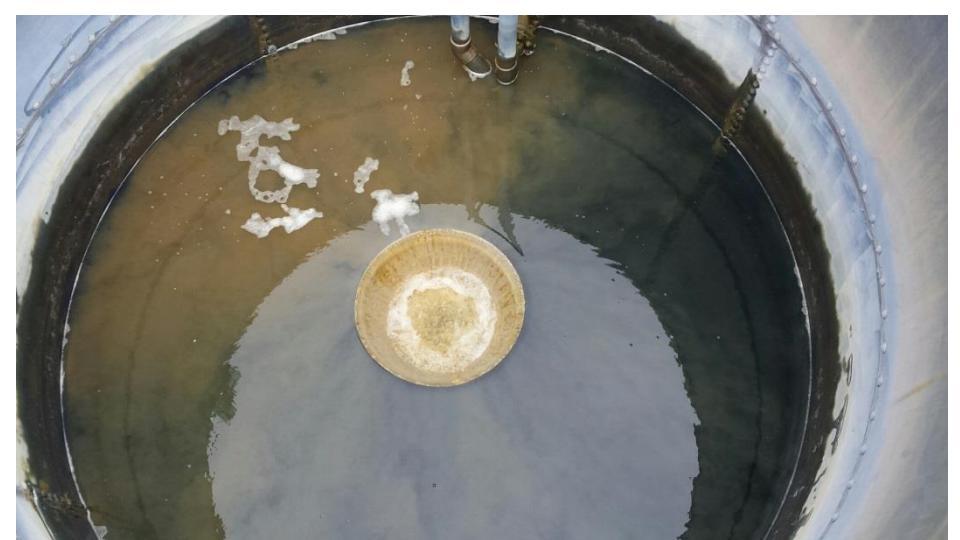
3.	Filtration				
	 a. The clarified water passes to 2 no. circular tank rapid gravity filters. b. The filter media was replaced 3 months ago, and consists of silica sand and anthracite. c. As a result of the recent filter upgrade, backwashing is now triggered by turbidity and head loss, in addition to time (usually one backwash per day) and manual activation. d. Following backwashing, the filters are run to waste until a target turbidity level is achieved. e. A backwash of Filter No. 2 was observed. The air scour was even across the bed. The water wash did not run completely clean during the backwash process. There was evidence of sludge build-up on the inside wall of the filter, which remained after the backwash (see photo 3). f. The turbidity level post-Filter No. 2 was 0.051 NTU.

Photo 3: Filter No. 2 showing uneven flow of backwash water/cleaning of filter & sludge build-up on filter walls

6. Irish Water should ensure that the backwash is even across the filters and the water wash runs completely clean during the backwash process.

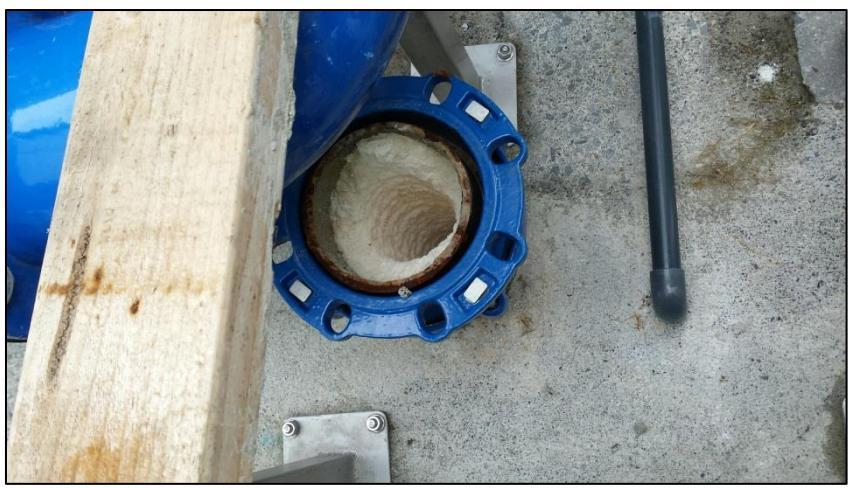
5.	 Final pH adjustment a. A new final pH adjustment stage has been introduced at the plant, where caustic (25% sodium hydroxide) is dosed to achieve a target 7.3 pH in the final water. b. The pipeline to the clear water tank has become blocked with caustic soda (see photo 4). Temporary pipework and access manhole is now in place (see photo 5) while Irish Water investigates the problem & implements the best solution. No timeframe was confirmed for this work but Irish Water expects it to be completed by end Q2 2017.

Photo 4: Build-up of sodium hydroxide in the treated water pipeline prior to clear water tank

8. Irish Water should implement a permanent solution to the caustic blockage of the pipeline entering the clear water tank. Irish Water should ensure that all access hatches on the clear water tank are sealed and locked.

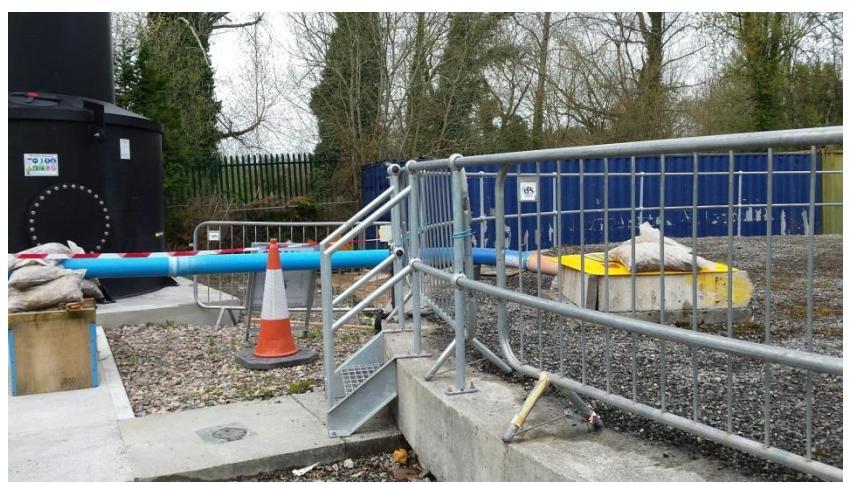
Photo 5: Temporary pipework & access manhole at clear water tank

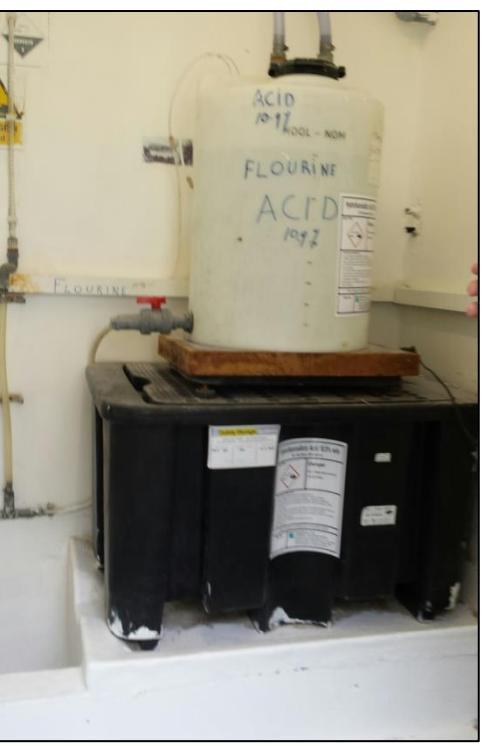
8.	Chemical storage and bunds			
	a.	The current arrangement of the hydrofluorosilicic acid day tank bund presents a risk that any potential acid spillage or leakage may not be contained within the bund (see photo 6).

Photo 6: Hydrofluorosilicic Acid day tank bunding arrangement

9. Irish Water should review the hydrofluorosilicic acid day tank bunding arrangements to ensure that any potential acid spillage or leakage will be contained in the bund.
